**ALABAMA HAZARDOUS WASTES MANAGEMENT AND MINIMIZATION ACT  
(AHWMMA)**

**Compliance Evaluation Inspection (CEI) Report**

**Rehau Auto LLC & Rehau Construction LLC (Rehau)**  
2424 Industrial Drive SW  
Cullman, AL 35055  
EPA ID Number: ALR000000612  
NAICS Code: 326199  
Website: www.Rehau.com

12/2/2019

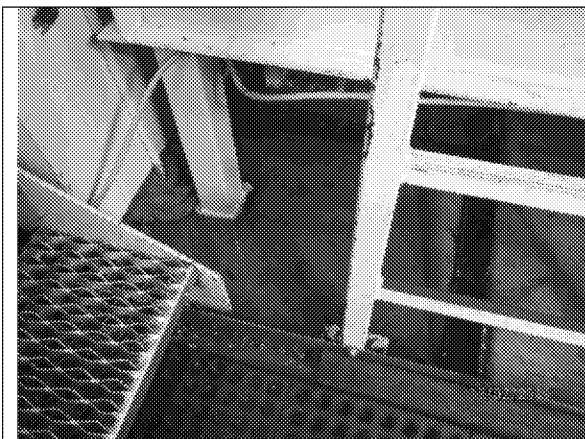
Used Oil in Secondary Containment

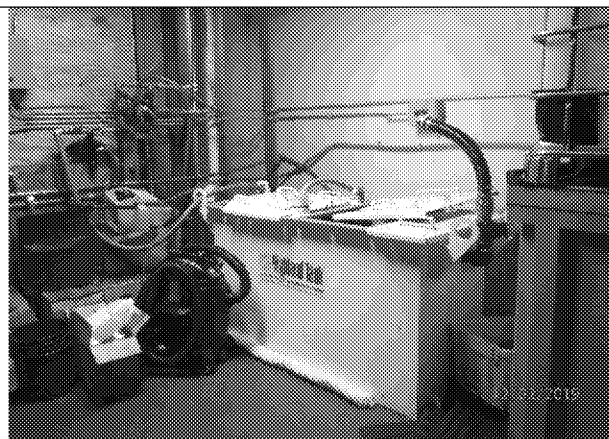
There were three mop buckets on the floor with oily water in them. The contents of the buckets will be poured into the oil/water separator, according to Mr. Mullaney. One 300 gallon tote of used hydraulic fluid was observed on a transfer platform. This platform also served as the secondary containment ~~e-secondary containment~~ for the tote and it was completely filled with used oil. One 55-gallon drum for used oil was observed open and not labeled with the words "Used Oil". No other concerns were noted in this area.

Oil/Water Separator and one mop bucket  
containing oily water

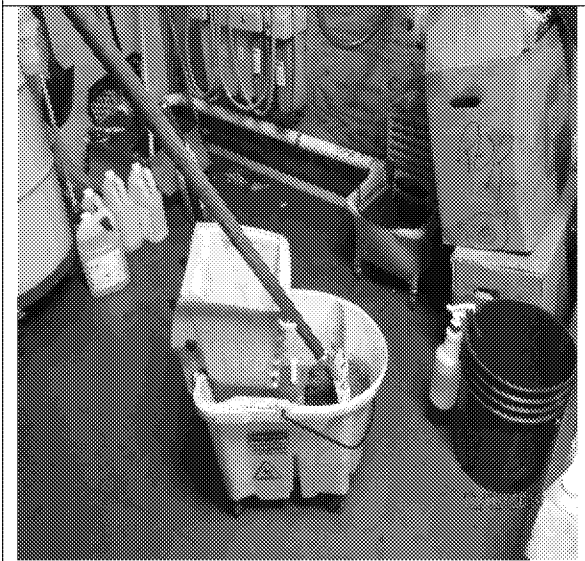
mop bucket containing oily water

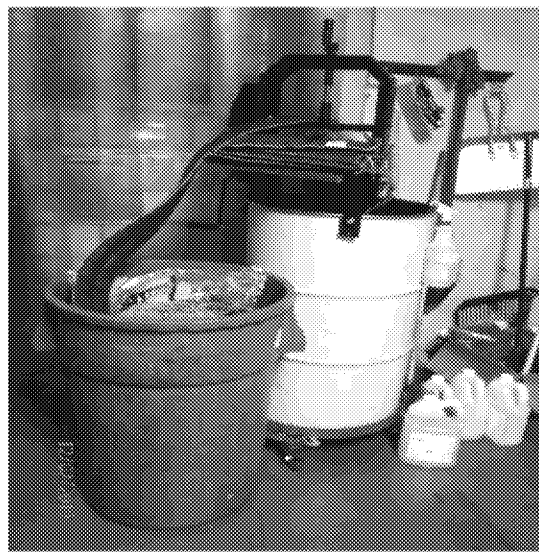
Absorbent pads satellite accumulation

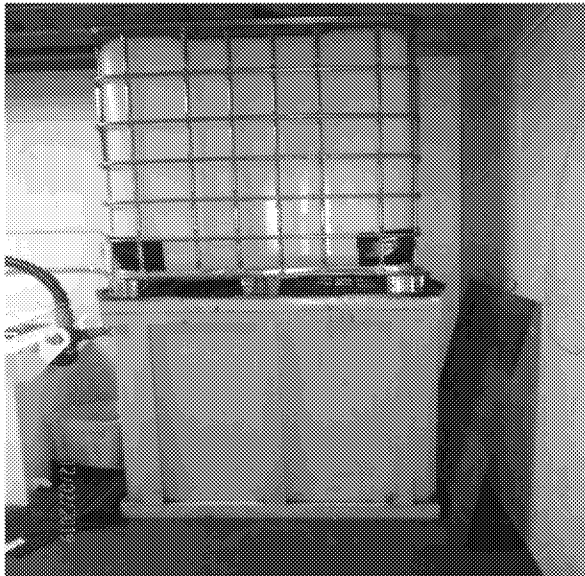
300 gallon Tote Platform

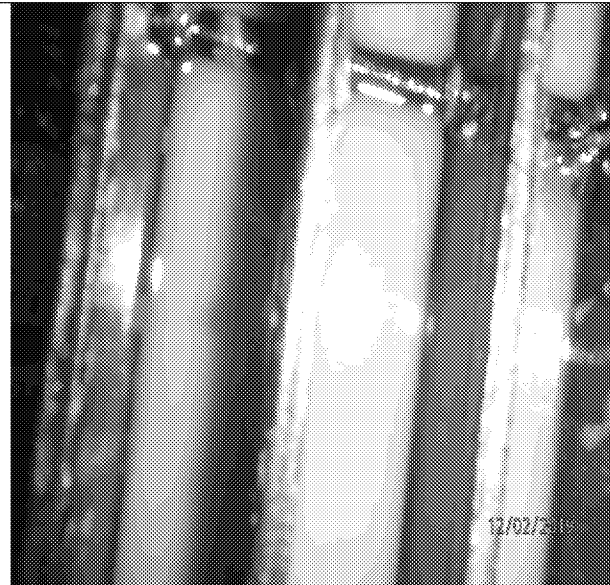
Secondary Containment; Tote Platform

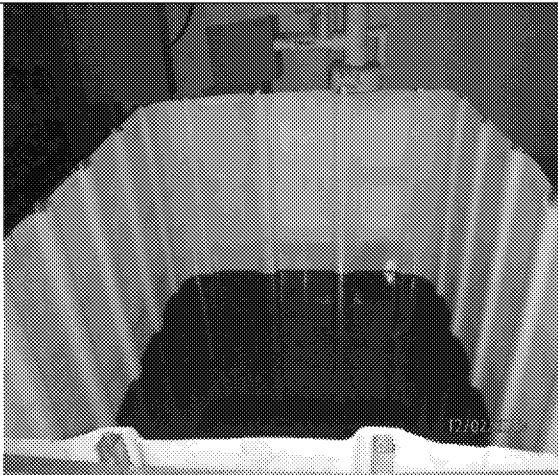
Used oil in a tote that was cut in half

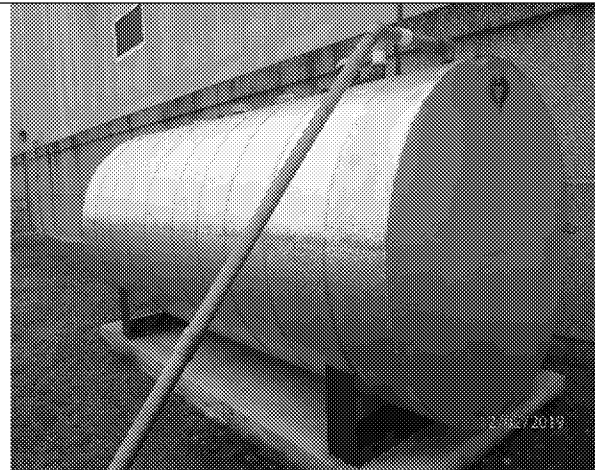
The used oil storage tank is adjacent to the oil/water separator room on a concrete pad on the outside of the building. The tank is approximately 10,000 gallons. The tank was not labeled with the words "Used Oil", but was in good condition. No other concerns were noted in this area.

Used oil storage tank

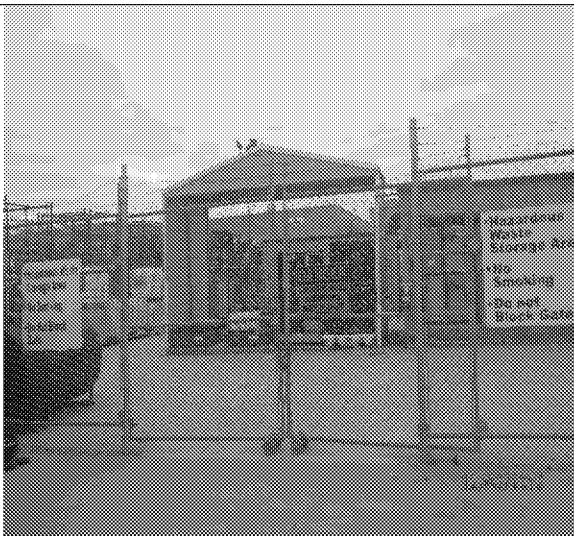
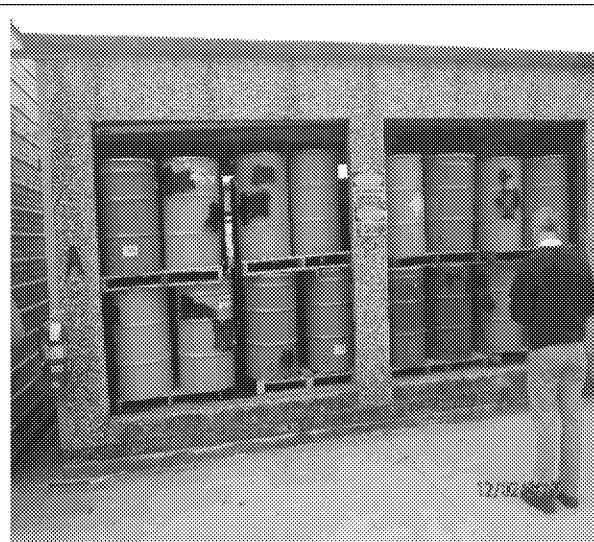
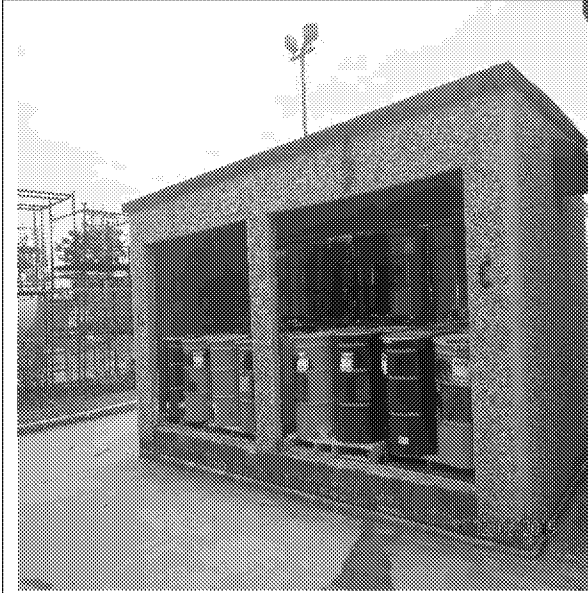
The hazardous waste storage area is also located on the south side of the facility in a fenced area outside. The area has the appropriate signage at every approach and has a means to control access to the area. There were fifty-five 55-gallon drums, one 300-gallon tote, and four 3-gallon buckets of hazardous waste in the area. All of the containers were closed, labeled, dated, and in good condition. The oldest container was dated 9/14/19. The secondary containment appeared to be in good condition and was free of any cracks or gaps. No areas of concern were noted in this area.

Hazardous Waste Storage Area

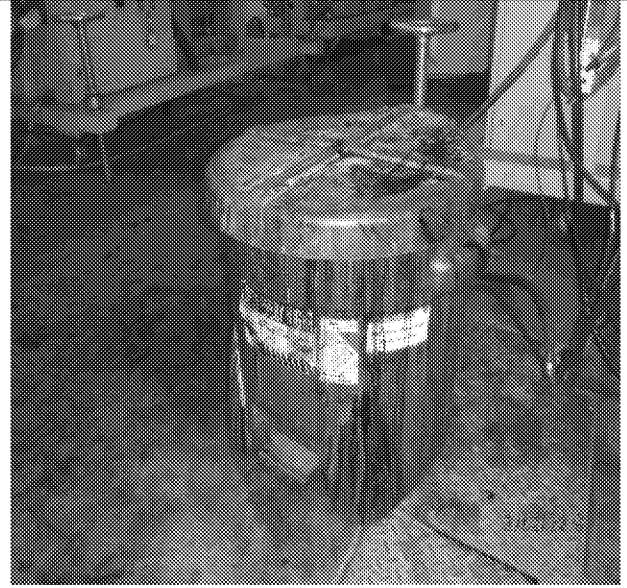
In this area, plastic pellets are extruded into hollow tubing of varying diameters for various application. There was one 55-gallon drum designated for hazardous waste at the beginning of the line. The drum was labeled, but not closed. This area has approximately twelve production lines with a 5-gallon satellite accumulation container at the end of each line. All of these containers were missing the words "Hazardous Waste". No other areas of concern were noted in this area.

Satellite Accumulation Container; PEX II line
